Aston / Chrysler V8 Bulletin

At WOSP we offer a range of different Aston Martin / Chrysler V8 starter motors, each designed to help make your installation process easier. Ranging from power, LH/RH Terminals which affects the angles of the motor bolts and Rotatable or Fixed mounts. At WOSP we are bound to have the correct starter motor for you and strive to make your decision in choosing what's best for you easier.

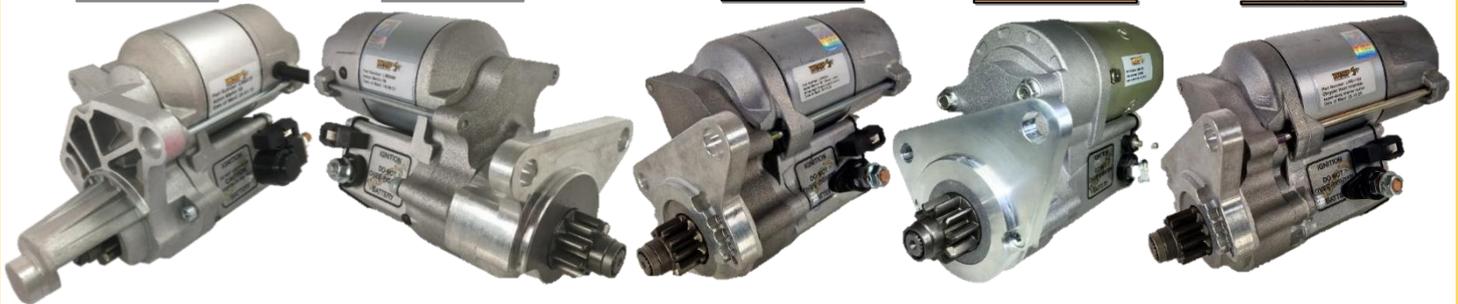
The entry level Aston Martin, Chrysler, Hemi, Mopar **LMS012** is a fixed mount starter. The other options we offer at WOSP: **LMS568** (Specifically designed to clear exhaust headers on an Aston Martin DBS V8), **LMS569**, **LMS924**, **LMS1152**, **LMS1412** have all been designed to be rotatable whilst mounting. These can be seen below.

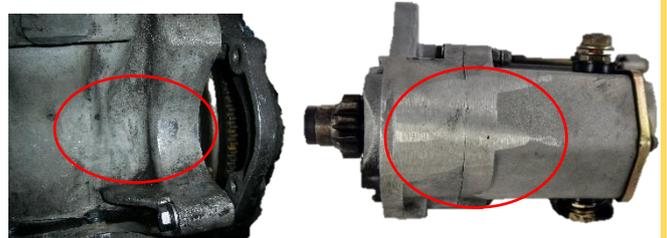
Filed Down LMS012 Example

N.B. SOME INSTALLATIONS MAY HAVE A CLASH OR CLEARANCE ISSUE WITH THE ENGINE BLOCK!

Due to several (reported as many as 7) different manufacturers of the engine block over the years, the block thickness itself can vary thus making the issue more prominent on some engines, however, you may not have an issue at all on others. Sadly no one can be any more conclusive than this.

With an Aston Martin V8 (which was fundamentally a Chrysler V8 block) the chance of an issue is less prominent on manual transmission cars (as opposed to automatic) as a shim was apparently used to move the OEM & subsequently our starter also back away from the mounting face thus giving the starter more clearance at the problem area.

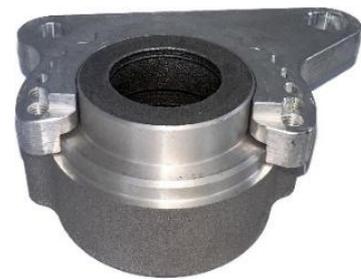
The Problem area & How our rotatable units improve fitment

The nose found on the **LMS012** can help location on some installations but ultimately is there solely for aesthetic reasons not for function.
