Aston / Chrysler V8 Bulletin

Potential clearance Issues

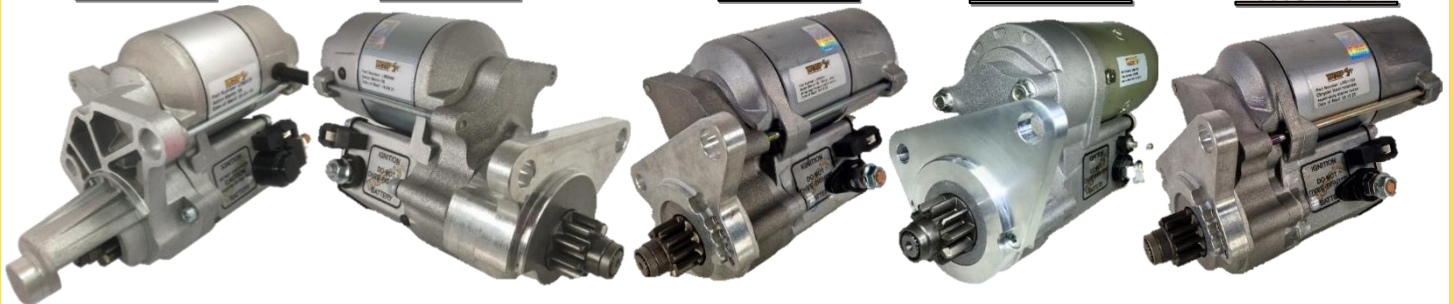
The entry level Aston Martin, Chrysler, Hemi, Mopar **LMS012** is a fixed mount starter. The other options we offer at WOSP: **LMS568** (Specifically designed to clear exhaust headers on an Aston Martin DBS V8), **LMS569**, **LMS924**, **LMS1152**, **LMS1412** have all been designed to be rotatable whilst mounting. These can be seen below.

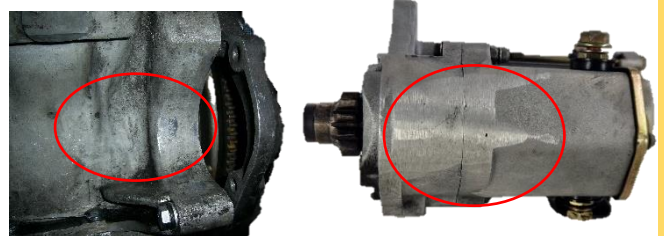
Filed Down LMS012 Example

N.B. SOME INSTALLATIONS MAY HAVE A CLASH OR CLEARANCE ISSUE WITH THE ENGINE BLOCK!

Due to several (reported as many as 7) different manufacturers of the engine block over the years, the block thickness itself can vary thus making the issue more prominent on some engines, however, you may not have an issue at all on others. Sadly no one can be any more conclusive than this.

With an Aston Martin V8 (which was fundamentally a Chrysler V8 block) the chance of an issue is less prominent on manual transmission cars (as opposed to automatic) as a shim was apparently used to move the OEM & subsequently our starter also back away from the mounting face thus giving the starter more clearance at the problem area.

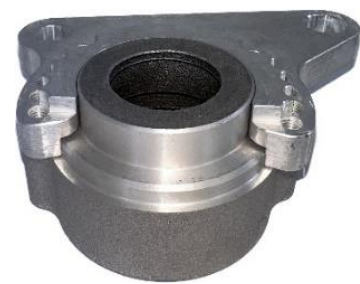
The Problem area & How our rotatable units improve fitment

LMS568

The nose found on the **LMS012** can help location on some installations but ultimately is there solely for aesthetic reasons not for function.
